AIR CONDITIONING CLUTCH

TROUBLESHOOTING GUIDE

This guide covers **WARNER ELECTRIC** clutches used on popular compressor makes

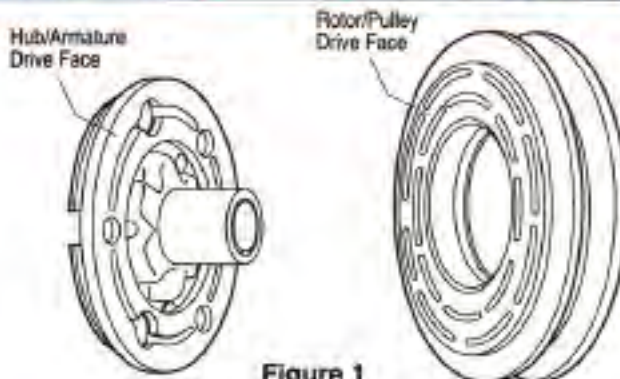
Figure 1

Is oil or grease on the clutch or on the hub/armature and rotor/pulley drive faces? See Figure 1.

- A. Compressor shaft seal leak.
- B. Compressor through-bolt leak.
- C. External oil source, such as engine oil, power steering fluid, etc.

Replace clutch. Locate source of oil and/or grease and repair. Replace or repair compressor as required.

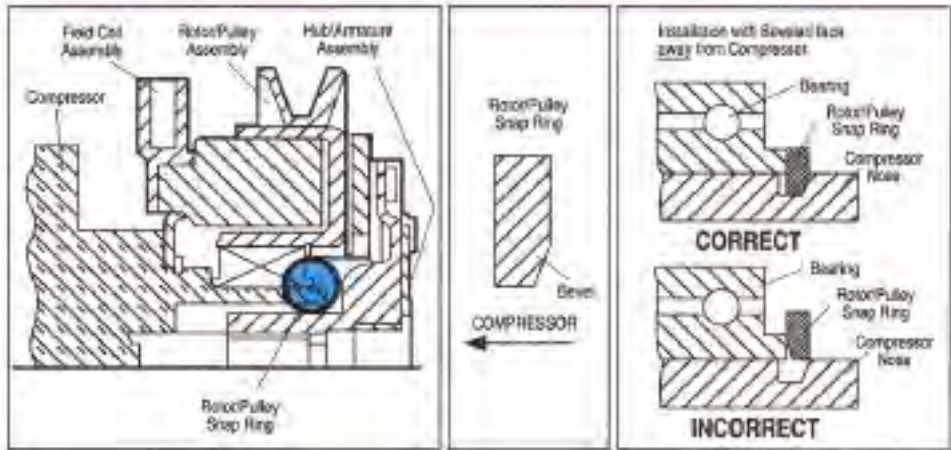
Figure 2

STEP 2
 Remove the hub/armature. Is the rotor/pulley snap ring missing or improperly installed?
 See Figure 2.

The rotor/pulley snap ring was not installed or was improperly installed.

Replace the clutch.
 Repair or replace compressor as required.

- The bevel on the rotor/pulley snap ring **MUST** face away from the compressor. See Figures 2A, B, C.
- The rotor/pulley snap ring must be seated fully in the groove. See Figure 2C.

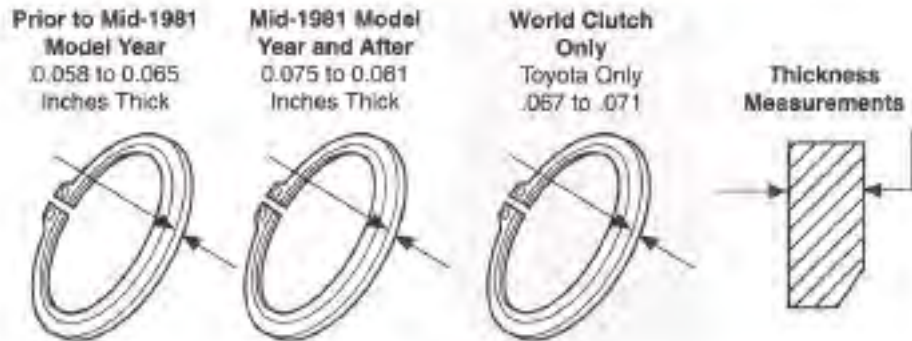
Figure 3

STEP 4
 Is the field coil snap ring the correct ring? See Figure 3. Is it installed correctly? See Figure 4, page 6.

During the 1981 model year, the field coil ring used to hold the field assembly in place was made thicker. (Ford FS-6 and Chrysler only).

A. Wrong field coil snap ring.

Be sure to use the correct field coil snap ring. See Figure 3.

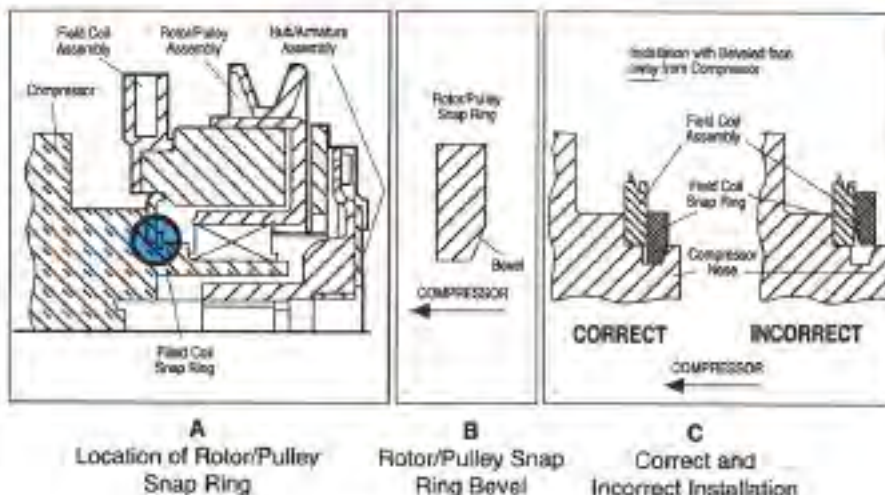
Figure 4

B. Field coil snap ring installed incorrectly.

- The bevel on the field retaining ring **MUST** face away from the compressor. See Figures 4A, B, C.
- The field retaining ring must be seated fully in the groove. See Figure 4C.
- The lug of the field retaining ring must **NOT** be positioned over the anti-rotation pin. See Figure 7.
- The field must be tight against the compressor.

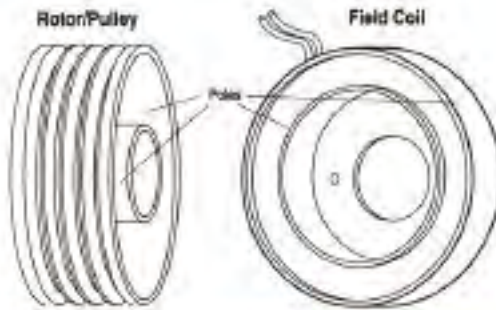
Figure 5

A typical indicator of improper field coil snap ring installation is rubbing between the field coil and rotor/pulley poles. See Figure 5. Also, if the field coil has an anti-rotation hole, the hole may be elongated or deformed from beating against the anti-rotation pin. See Figure 6.

NOTE: Check the compressor for anti-rotation pin damage. Repair or replace compressor as required. Replace clutch if damaged. Be sure to use the correct field coil snap ring. See Figure 3.

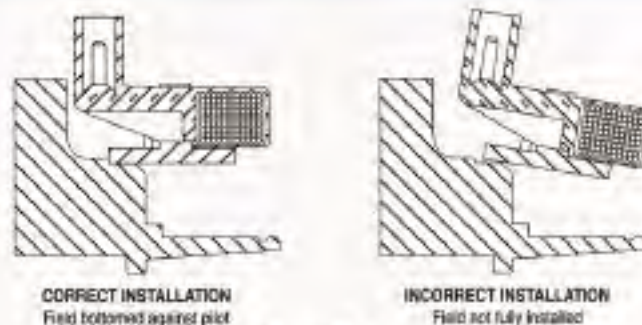
Is field assembly installed correctly? See Figure 7a for field assembly correctly bottomed onto pilot shoulder.

- Field assembly not bottomed completely onto shoulder.
- Compressor pilot diameter is worn undersize.
- Field shell pilot diameter is worn oversize.

Use proper installation tool to bottom assembly onto shoulder. Do Not press against plastic. Replace compressor and/or field assembly.

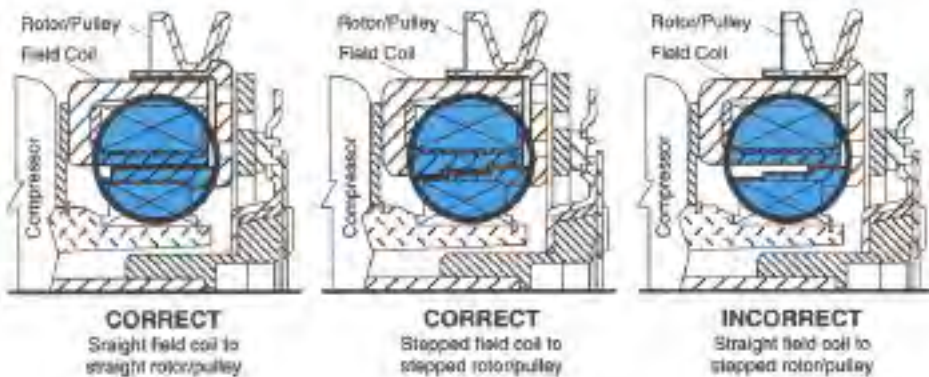
Figure 8

Are the clutch components mismatched? See Figure 8.

Straight inner pole field coil with a stepped inner pole rotor/pulley.

Replace the clutch.
 Repair or replace compressor as required.

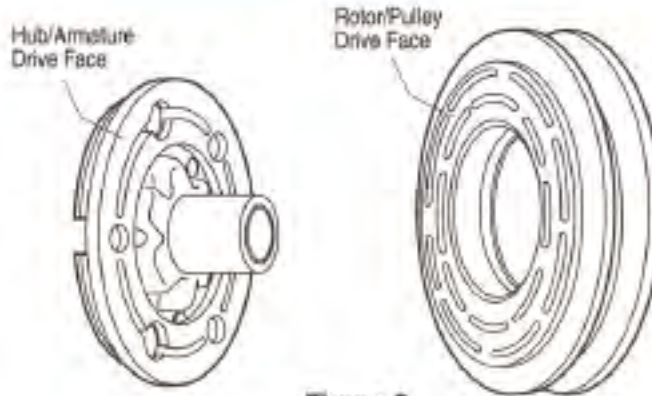
Figure 9

Is oil or grease on the clutch or on the hub/armature and rotor/pulley drive faces? See Figure 9.

- A. Compressor shaft seal leak.
- B. Compressor through-bolt leak.
- C. External oil source, such as engine oil, power steering fluid, etc.
- D. Contaminated with grease or oil during installation.

Replace clutch. Locate source of oil and/or grease and repair. Replace or repair compressor as required.

NOTE: Clutch drive faces MUST be free of ALL grease or oil.

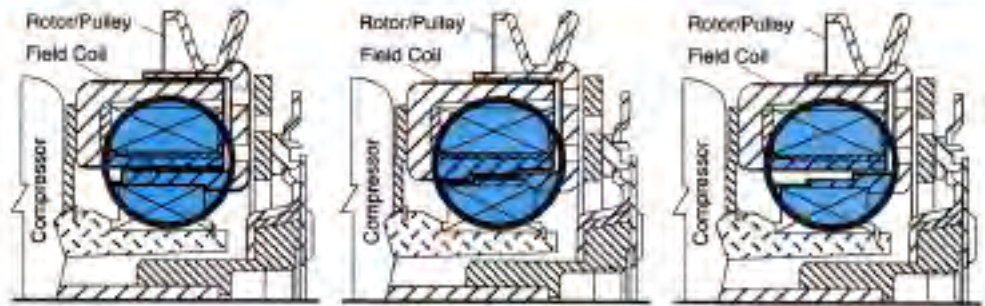
Figure 10

Are the clutch components mismatched? See Figure 10.
 NOTE: World Clutch field and rotors will not physically fit with the previous model field and rotor components.

Straight inner pole field coil with a stepped inner pole rotor/pulley.

Replace the clutch.
 Repair or replace compressor as required.

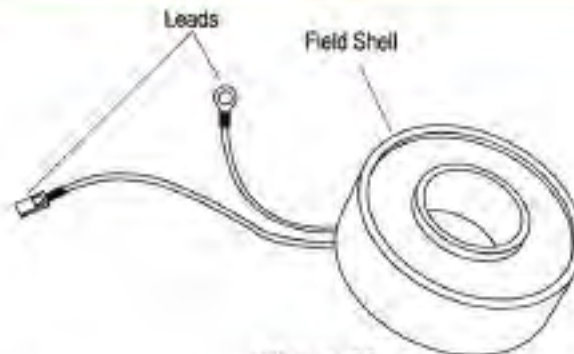
Figure 11

Check resistance of the field coil between both leads. See Figure 11. Is the resistance less than 2.0 ohms?

NOTE: World clutch field coil resistance is 3.2 ohms minimum.

Shorted field coil.

Replace field coil.

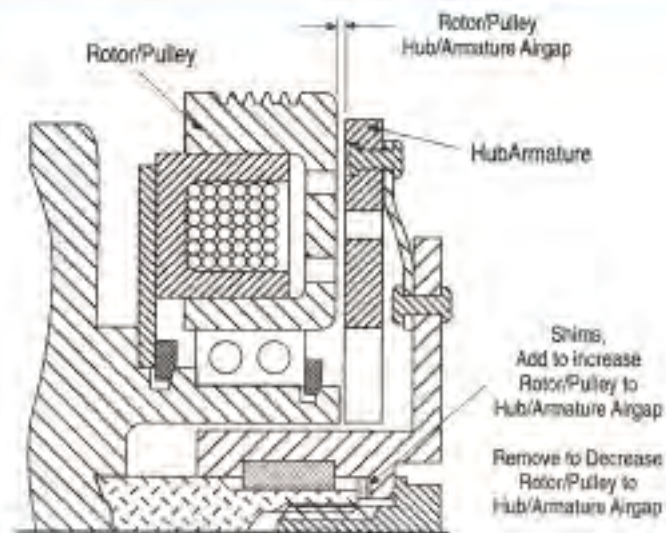
STEP 3
 Disconnect the field coil electrical connections and rotate the rotor/pulley. Is the hub/armature dragging on the rotor/pulley? See Figure 12

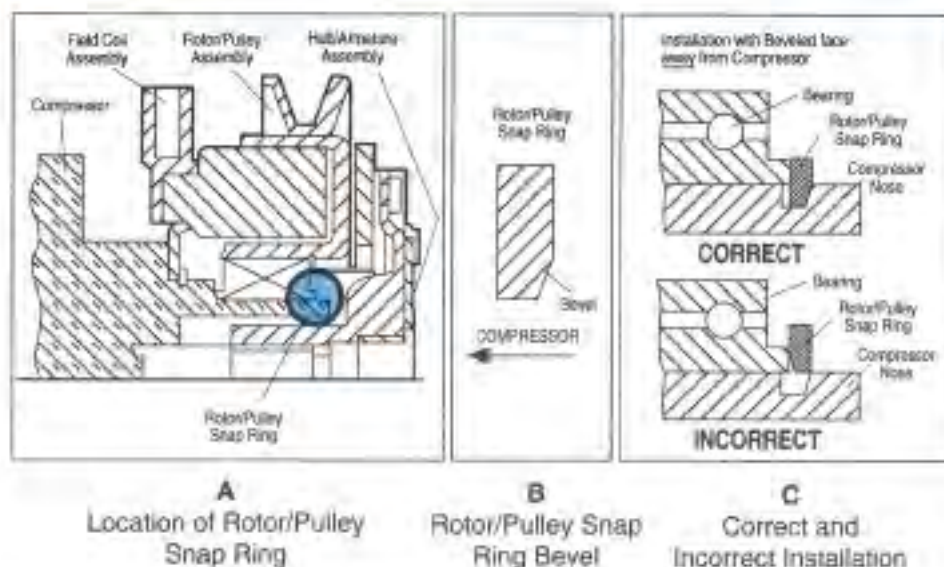
Figure 13

STEP 4
 Remove the hub/armature. Is the rotor/pulley snap ring missing or improperly installed. See Figure 13.

INSPECTION	PRIMARY CAUSE(S)	CORRECTIVE ACTION
YES. →	The rotor/pulley snap ring was not installed or was improperly installed.	Replace clutch if damaged. Repair or replace compressor as required. IMPORTANT The bevel on the rotor/pulley snap ring MUST face away from the compressor. See Figures 13A, B, C. The rotor/pulley snap ring must be seated fully in the groove. See Figure 13C.
NO. →	Rotor/pulley to hub/armature air gap too small.	Reset the hub/armature to rotor/pulley air gap to 0.020 to 0.040 inch clearance by removing shims. World Clutch with Unidamp® Armature air gap settings are: New .018" to .030" and Used .013" to .025". See Figure 12. Measure the air gap between the hub/armature and rotor/pulley at three locations 120° apart using a feeler gage.

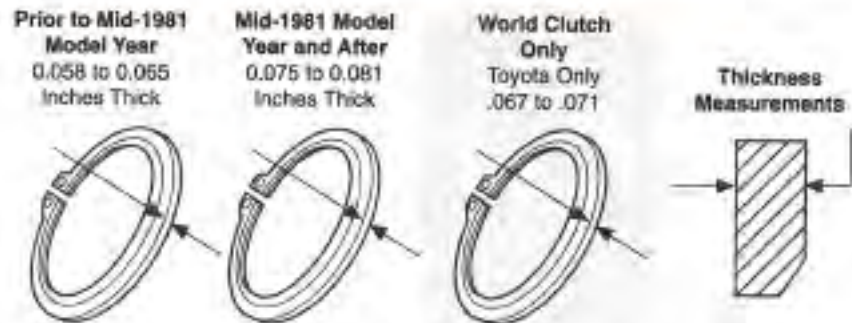
Figure 14

Is the field coil snap ring the correct ring? See Figure 14. Is it installed correctly? See Figure 15C.

During the 1981 model year, the field coil snap ring used to hold the field coil assembly in place was made thicker. (Ford FS-6 and Chrysler only.)

- A. Wrong field coil snap ring.
 B. Field coil snap ring installed incorrectly.

Replace clutch if damaged.
 ⚠ Be sure to use the correct field coil snap ring. See Fig. 14, page 13.
 Repair or replace compressor as required.

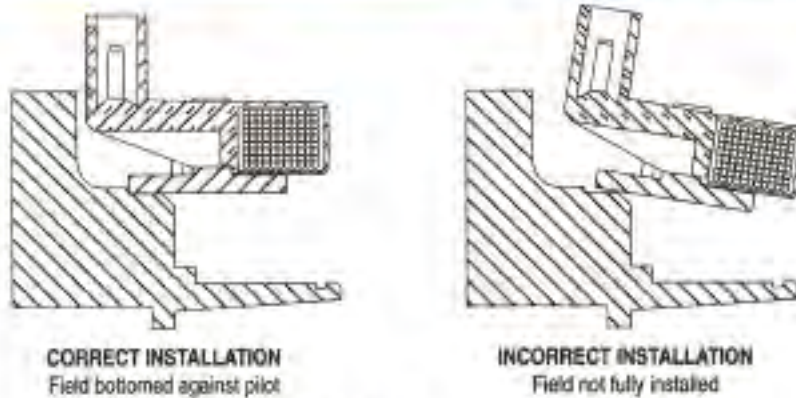
Is field assembly installed correctly? See Figure 18a for field assembly correctly bottomed onto pilot shoulder.

- A. Field assembly not bottomed completely onto shoulder.
- B. Compressor pilot diameter is worn undersize.
- C. Field shell pilot diameter is worn oversize.

Use proper installation tool to bottom assembly onto shoulder. Do Not press against plastic. Replace compressor and/or field assembly.

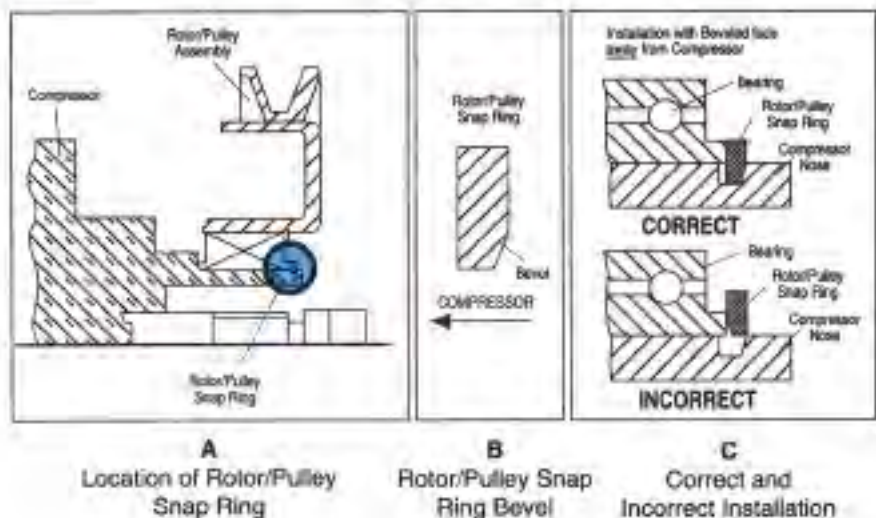
Figure 19

- ⚠ Be sure to install the rotor/pulley snap ring. See Figure 19. Idle the engine and listen for noise. Does the noise continue?

Damaged bearing.

Replace clutch.

- ⚠ Do not attempt to replace the bearing in the rotor/pulley.

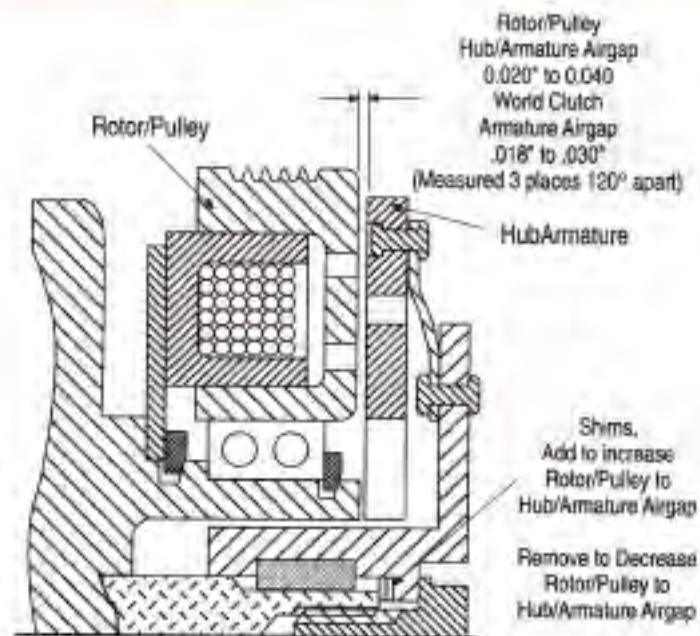
Figure 20

Check the hub/armature to rotor/pulley air gap. Does it exceed 0.125 inches? See Figure 20.

Air gap excessive.

Reset the hub/armature to rotor/pulley air gap to 0.020 to 0.040 inch clearance by removing shims. World Clutch with Unidamp® Armature airgap settings are New .018" to .030" or Used .013" to .025". See Figure 18. Measure the air gap between the hub/armature and rotor/pulley at three locations 120° apart using a feeler gauge.

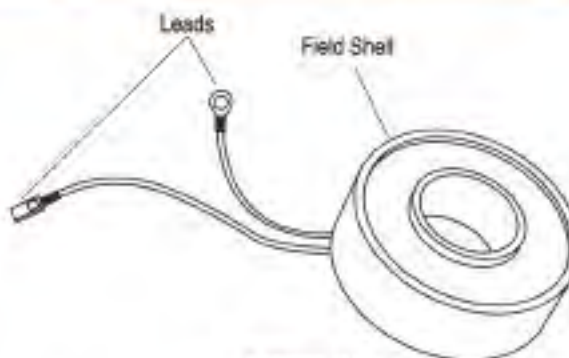
Figure 21

Check resistance of the field coil between both leads. See Figure 21. Is the resistance less than 2.0 ohms (or 3.2 ohms for a World Clutch field coil)?

Shorted field coil.

Is there continuity between either lead and the field shell? See Figure 21.

Is there continuity between the field coil leads? See Figure 21.

Replace field coil.

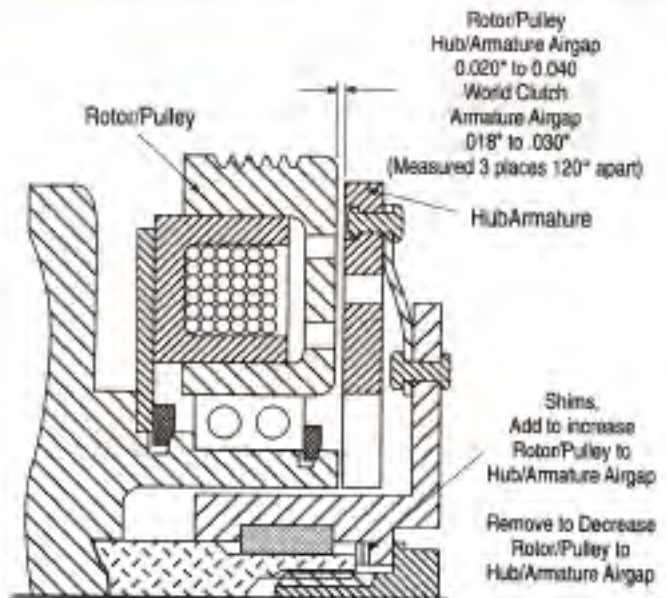
Figure 22

Disconnect the field coil electrical connections. Check the rotor/pulley to hub/armature air gap. See Figure 22. Is there a minimum of 0.020 inch clearance between the hub/armature and the rotor/pulley? World Clutch with Unidamp® armature has .010" minimum airgap.

INSPECTION	PRIMARY CAUSE(S)	CORRECTIVE ACTION
<p>NO. —————▶</p>	<p>The hub/armature to rotor/pulley air gap is too small.</p>	<p>Reinstall the armature and set the hub/armature to rotor/pulley air gap to 0.020 to 0.040 inch clearance by adding shims. World Clutch with Unidamp armature airgap settings are New .018" to .030" and Used .013 .025". See Figure 22. Measure the air gap between the hub/armature and rotor/pulley at three locations 120° apart using a feeler gauge.</p>

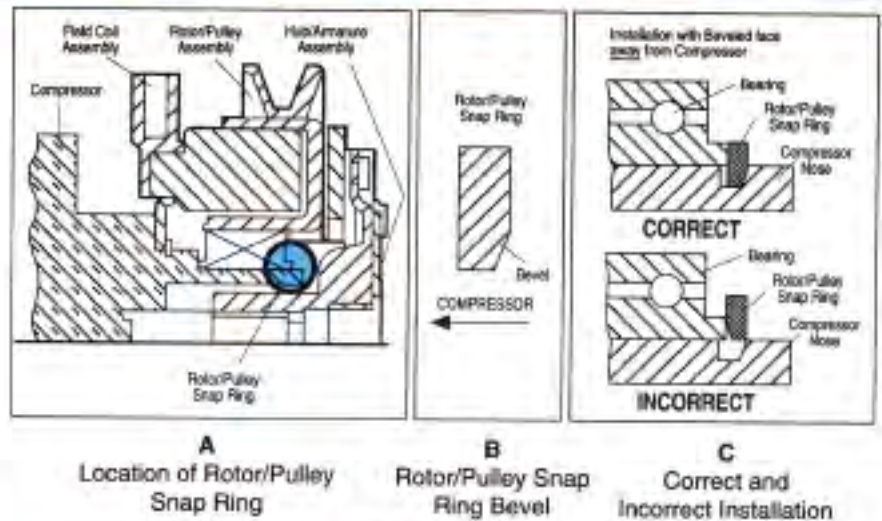
Figure 23

Remove the hub/armature. Is the rotor/pulley snap ring missing or improperly installed? See Figures 23.

The rotor/pulley snap ring was not installed or was improperly installed.

Replace the clutch if damaged. Repair or replace compressor as required.

- The bevel on the rotor/pulley snap ring **MUST** face away from the compressor. See Figures 23.
- The rotor/pulley snap ring must be seated fully in the groove. See Figure 23C.
- World Clutch with Unidamp® armature average airgap setting is:
 New: .018" to .030"
 Used: .013" to .025"
