AIR CONDITIONING CLUTCH

TROUBLESHOOTING GUIDE

This guide covers **WARNER ELECTRIC** clutches used on popular compressor makes

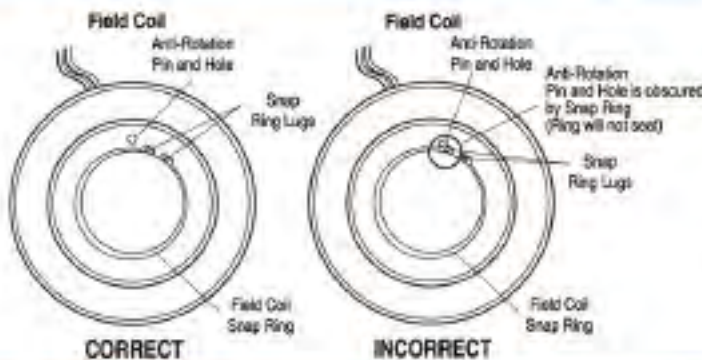
Figure 7

- The bevel on the field retaining ring **MUST** face away from the compressor. See Figures 4A, B, C.
- The field retaining ring must be seated fully in the groove. See Figure 4C.
- The lug of the field retaining ring must **NOT** be positioned over the anti-rotation pin. See Figure 7.
- The field must be tight against the compressor.

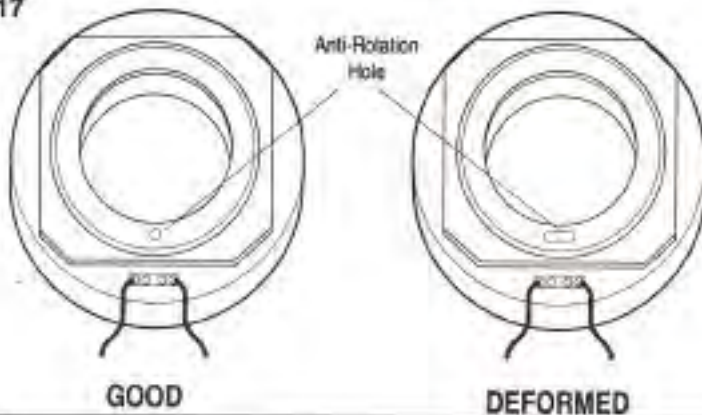
Figure 17

- IMPORTANT**
- The bevel on the field coil snap ring **MUST** face away from the compressor. See Figures 15A, B, C, page 13.
 - The field coil snap ring must be seated fully in the groove. See Figure 15C, page 13. A typical indicator of improper field coil snap ring installation is rubbing between the field coil and rotor/pulley poles. See Fig. 16. Also, if the field coil has an anti-rotation hole, the hole may be elongated or deformed from beating against the anti-rotation pin. See Figure 17.
 - The lug of the field coil snap ring must **NOT** be positioned over the anti-rotation pin. See Figure 18.
 - The field coil must be tight against the compressor (meaning the field coil cannot be rotated by hand or moved axially on the compressor).
